High Ground Property Inspections Home Inspection Report

123 Sample Inspection St
Orlando, FL 32812

Inspection Completed On: Sun, Jan 26, 2025 at
9:00 AM

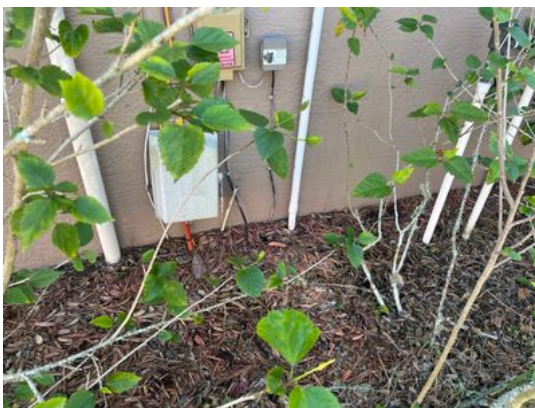
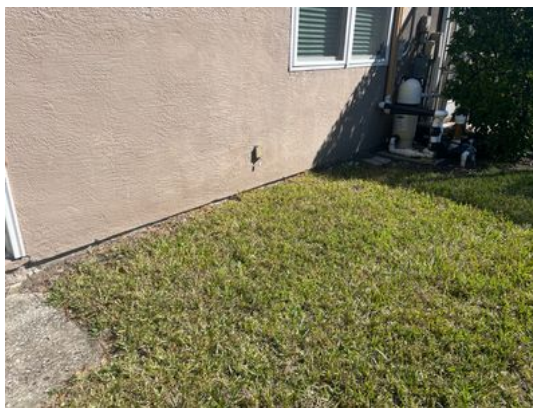
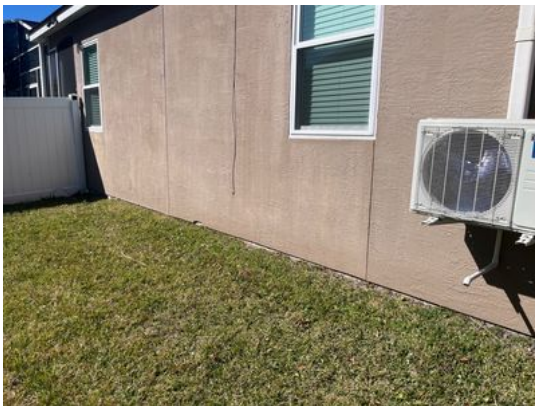
Comment 1

Lawn/landscaping abuts to exterior structure/wall covering at multiple locations. Recommend removal to expose slab and prevent infiltration of moisture and pests.

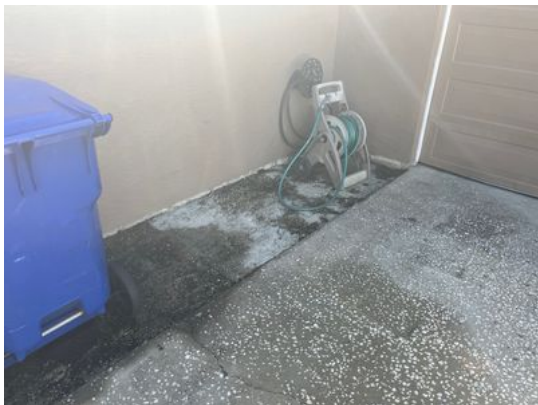
Comment 2

Concrete area on left side of garage door pools water and does not allow proper drainage away from the home. Recommend repair by qualified concrete contractor.

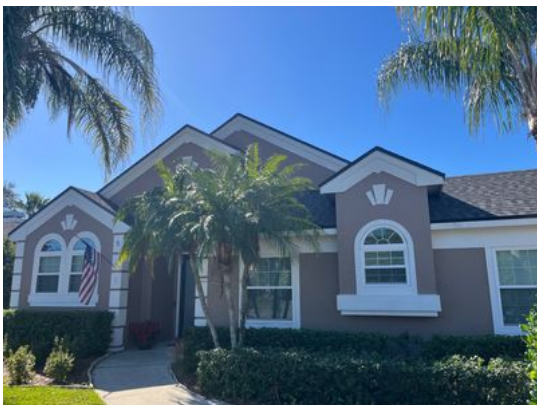
Comment 3

Recommend trimming palms in front of home to avoid brushing of fronds against roof surface.

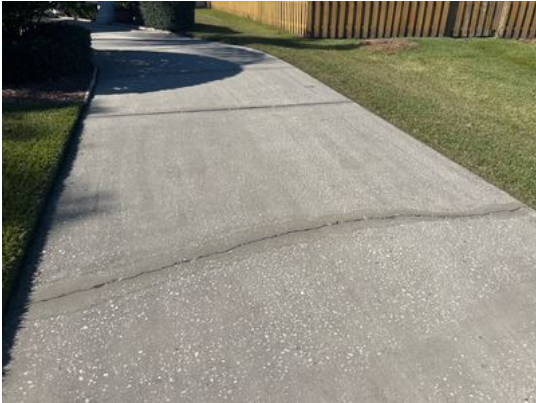
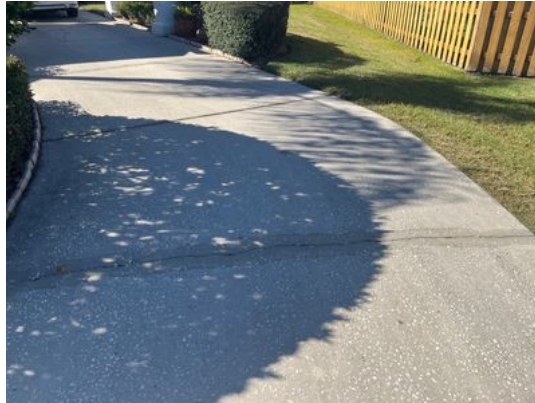
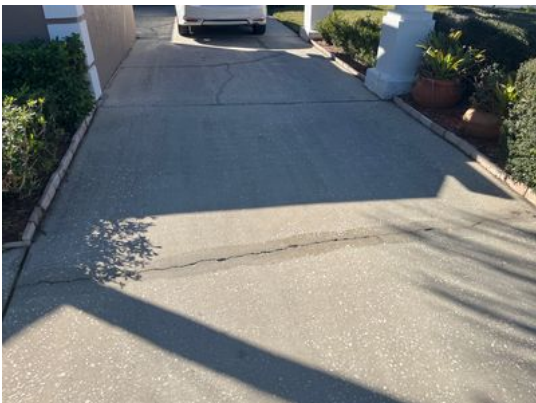
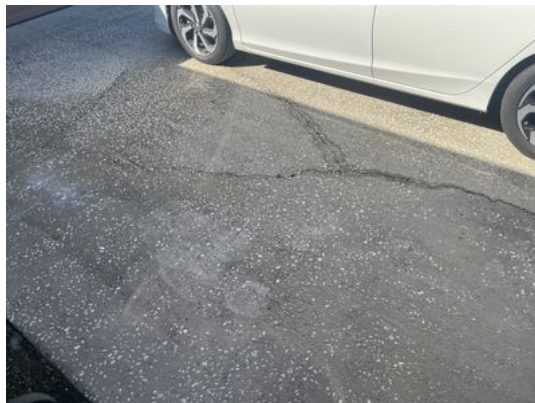
**Comment 4
Information**

Some cracking observed along driveway. This is typical of most large concrete surfaces beyond a certain age. Recommend ceiling cracks to mitigate further damage. No trip hazards observed present at time of inspection.

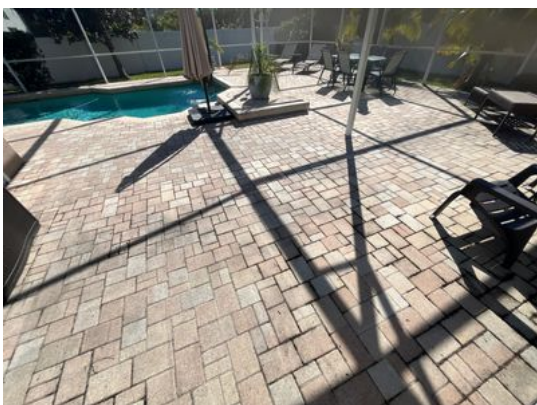
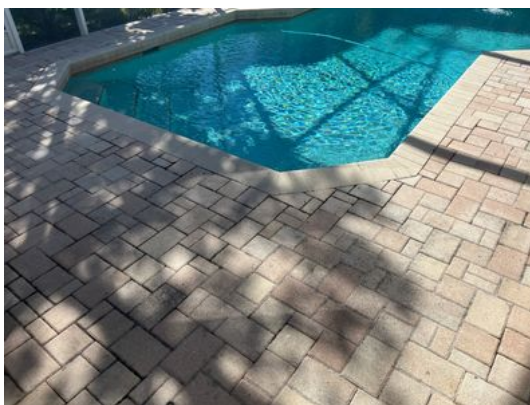
Comment 6 Information

Paver deck surrounding pool area appears to be in good condition. Recommend pressure washing and ceiling pavers to improve the general condition and aesthetic.

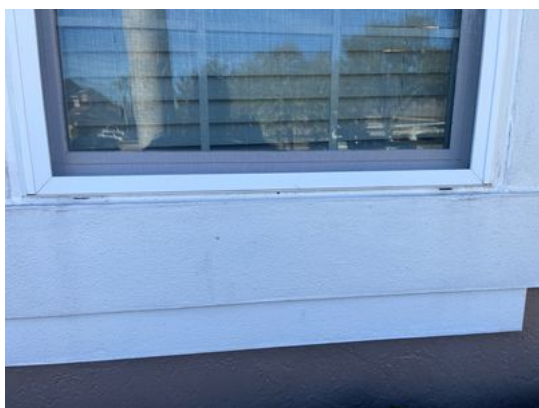
Comment 7 Information

Weep hole covers missing or partially obstructed at various locations. Recommend removing sealant near weep holes, and adding sponges where covers are missing to prevent intrusion of pests and debris. And promote proper drainage.

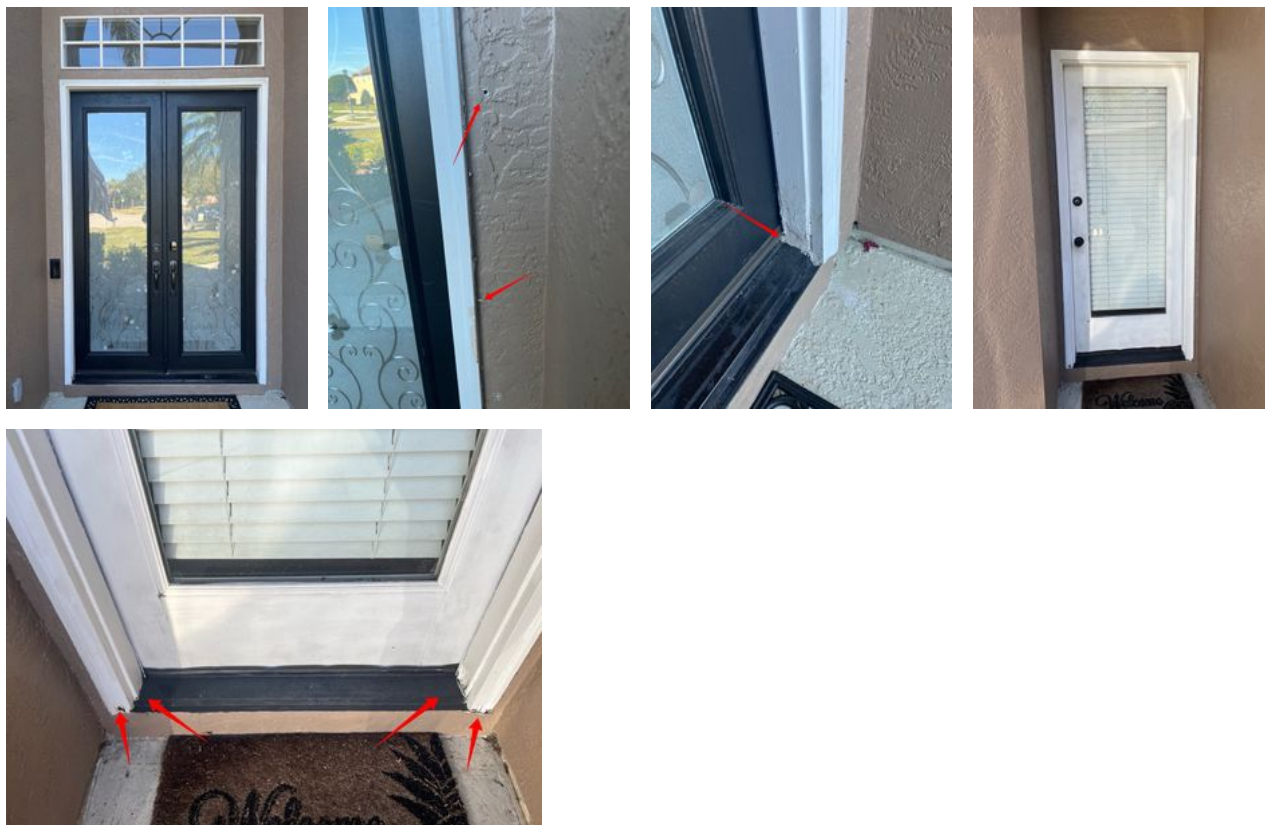
Comment 8 Repair or Replacement Needed

Multiple drilled holes along perimeter of main entry door recommend sealing to prevent intrusion of pests and moisture.

Caulking, along perimeter of main entry door frame has become separated. Recommend resealing.

Wood rot observed at base of main entry door frame, which has been improperly repaired. Recommend proper repair by a qualified person.

Wood rot observed at side entry door. Recommend repair by a qualified person.

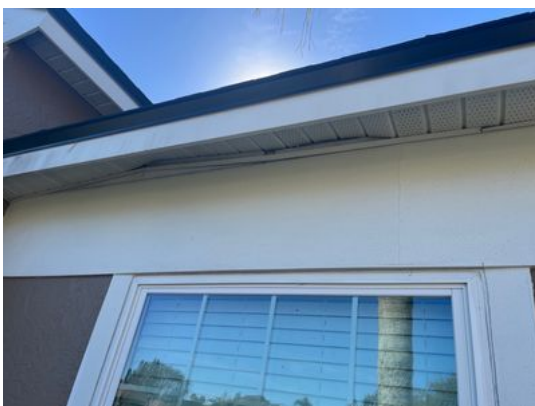
Soffit displaced on north side of home. Recommend adjustment to correct.

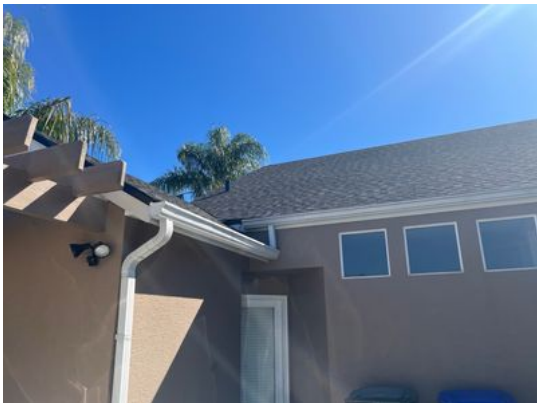
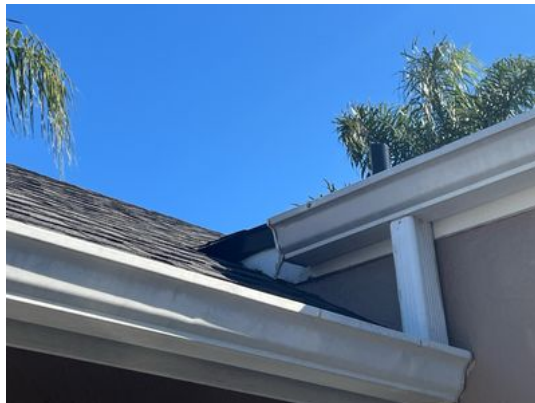
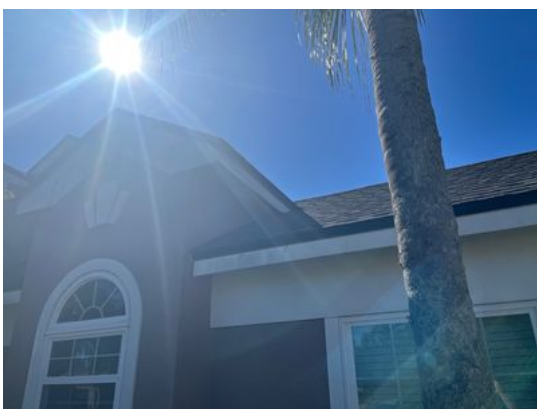
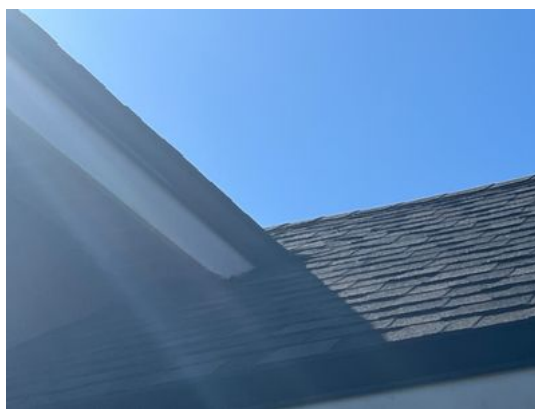
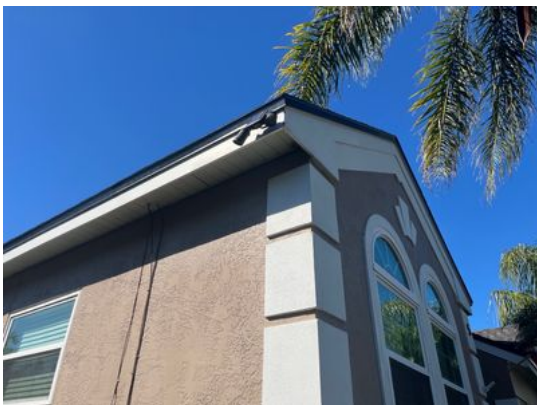
Comment 11

Minor indications of wood rot along fascia at multiple locations. Recommend addressing affected areas to prevent further damage.

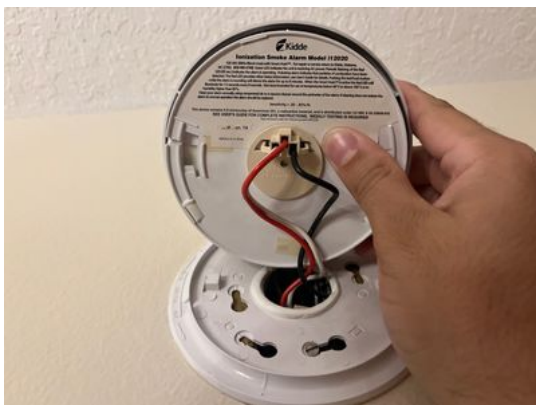
All three smoke detectors in home are over 10 years old. Recommend replacement to ensure effectiveness. Also recommend installation of a Carbon monoxide detector or combination smoke/CO detector in family room near fireplace and in kitchen near garage door.

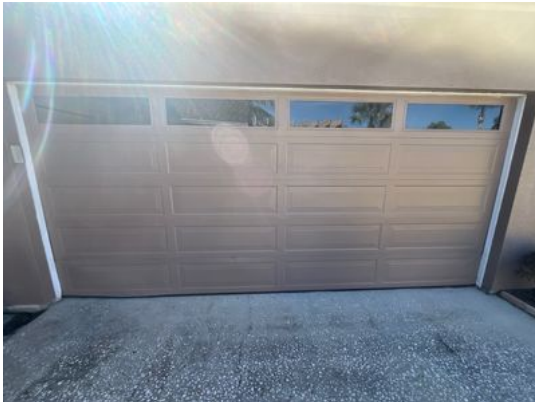
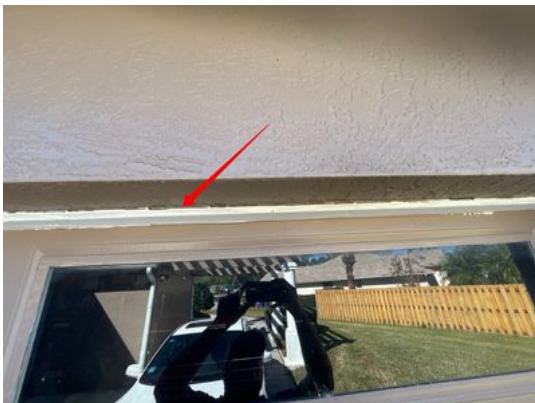
Minor wood rot present at trim surrounding garage door. Recommend repair.

Cosmetic defect noted at lower left side of garage door.

Seals missing along perimeter of garage door. Recommend addition of seals.

Caulking, missing/cracked at top of garage door trim. Recommend resealing

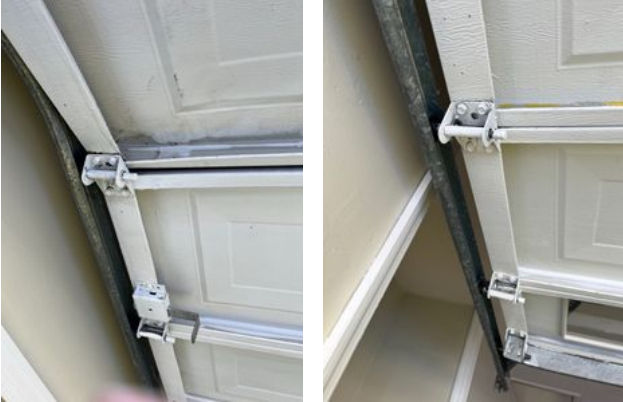
Garage door operates very loudly. Loose hinges identified on left side of door recommend maintenance/repair.

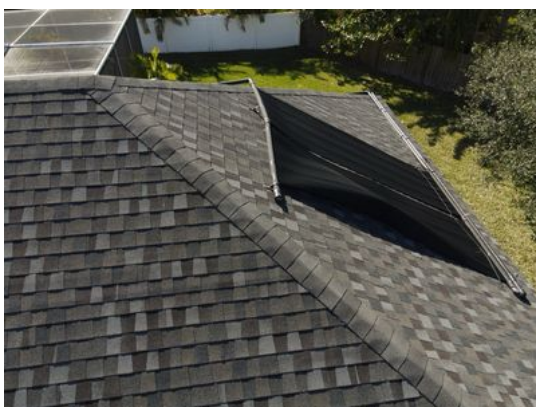
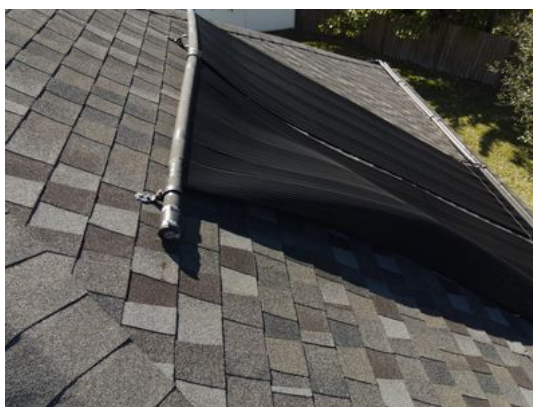
Solar pool heater controls not tested due to damaged panel on roof. Recommend replacement or repair of panel by a qualified professional.

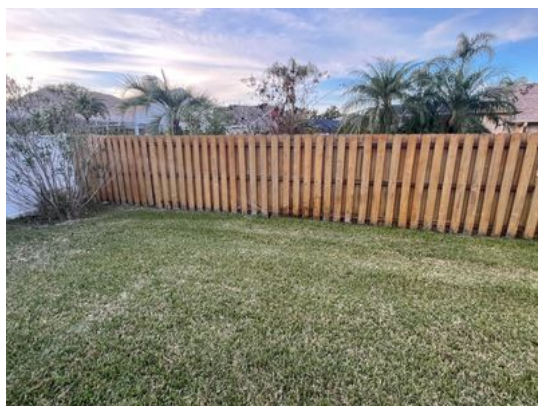
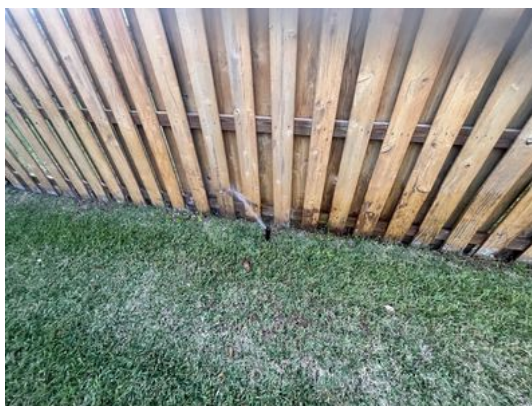
Rotor spraying fence on west side of home. Recommend adjustment.

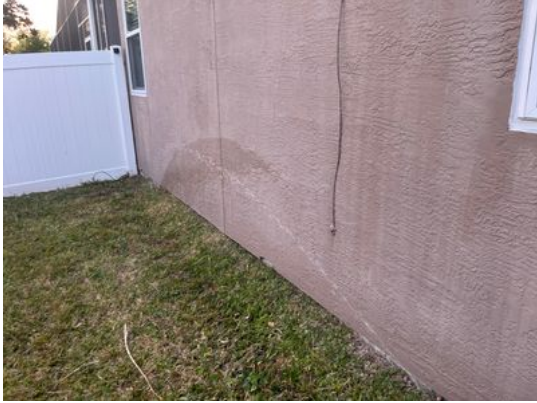
Rotor spraying stucco at east side of home. Recommend adjustment.

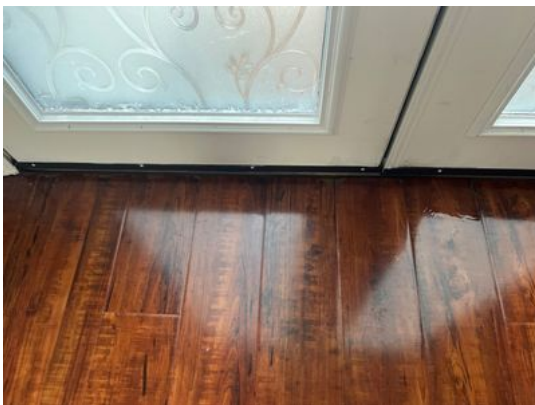
Comment 26 Information

Threshold trim missing between flooring and doorway. Some warping of laminate present.

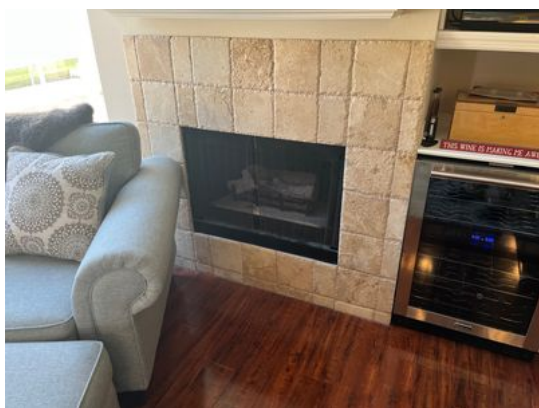
Comment 30

Fireplace was not tested as fuel source is disconnected. Connection at exterior has visible corrosion. Recommend further evaluation by a fireplace professional.

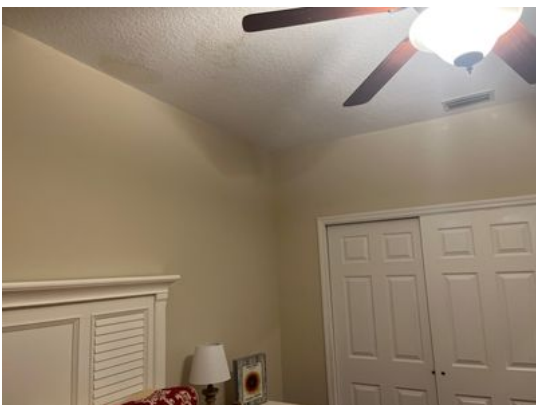
Comment 38

Staining noted on ceiling near exterior entry wall. Surface confirmed as dry using moisture meter and thermal imaging. Recommend repair of affected area by a professional repair person.

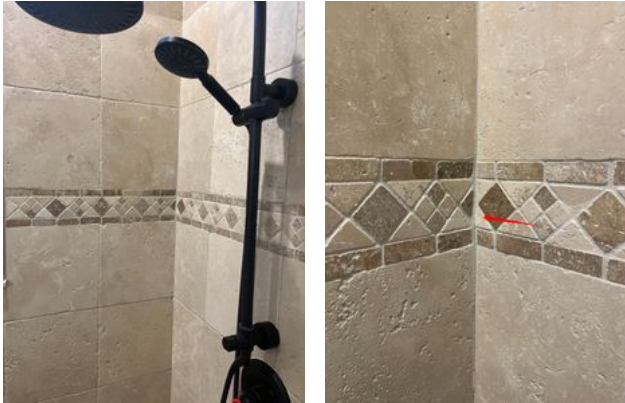
Cracks present in grout in shower enclosure. Recommend repairing grout to prevent moisture intrusion.

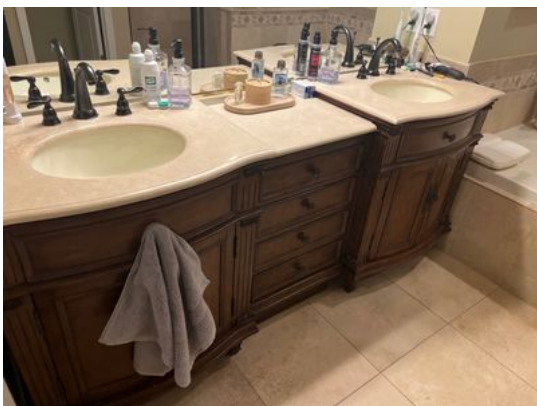
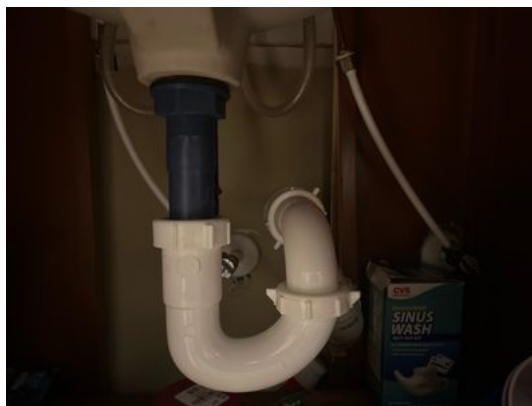
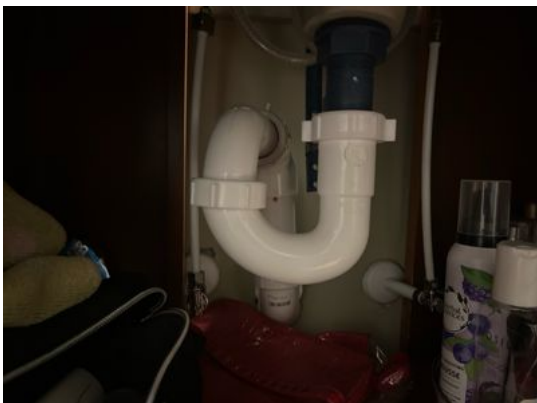
Comment 43

Right sink does not drain properly. Possibly clogged. Recommend maintenance.

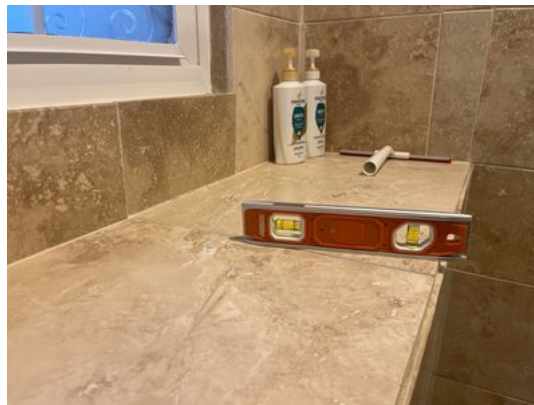
Tile work at shower enclosure slopes towards bay window, preventing proper drainage. Bullnose missing at ledge exposes sharp joint in tile-work.

Tile at window sill creates a pocket that retains water

Recommend consulting with a professional tile installer or general contractor.

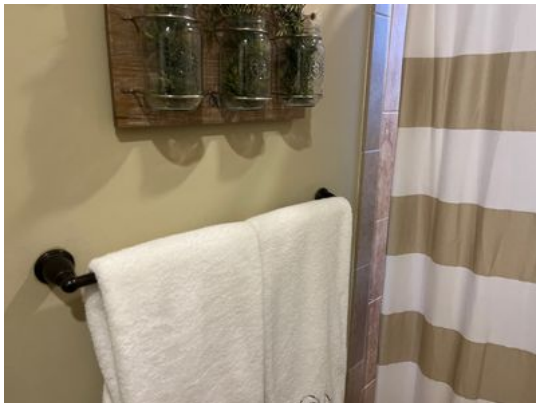
Towel rack loose. Recommend removal and reinstallation to repair.

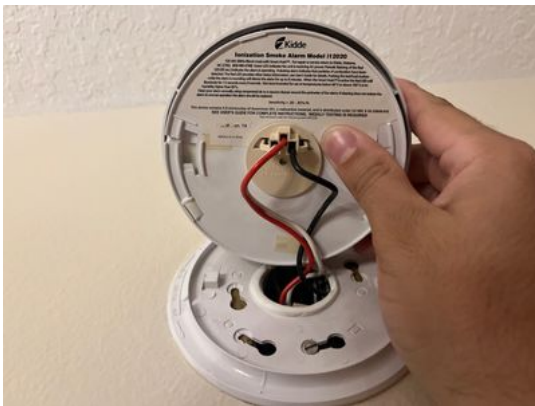
All three smoke detectors in home are over 10 years old. Recommend replacement to ensure effectiveness. Also recommend installation of a Carbon monoxide detector or combination smoke/CO detector in family room near fireplace and in kitchen near garage door.

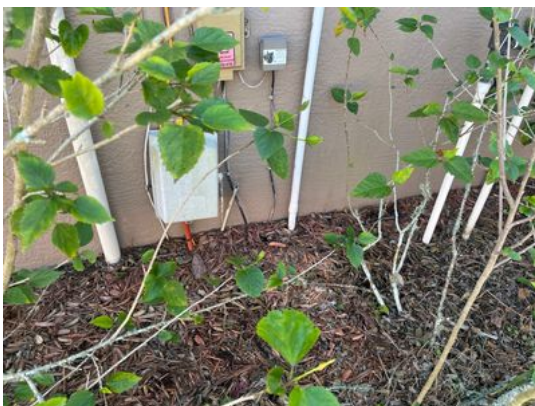
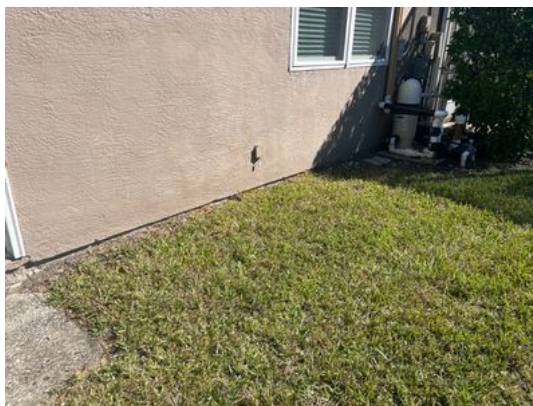
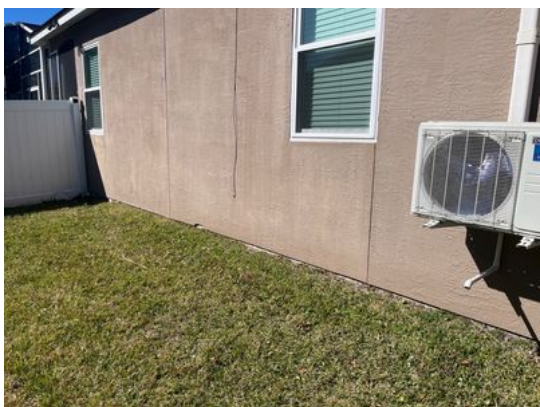
Comment 1

Lawn/landscaping abuts to exterior structure/wall covering at multiple locations. Recommend removal to expose slab and prevent infiltration of moisture and pests.

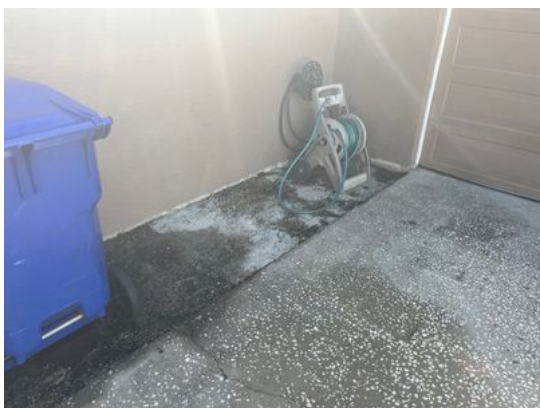
Comment 2

Concrete area on left side of garage door pools water and does not allow proper drainage away from the home. Recommend repair by qualified concrete contractor.

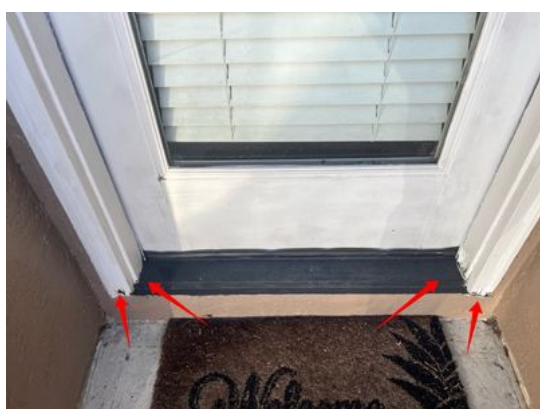
Comment 8

Multiple drilled holes along perimeter of main entry door recommend sealing to prevent intrusion of pests and moisture.

Caulking, along perimeter of main entry door frame has become separated. Recommend resealing.

Wood rot observed at base of main entry door frame, which has been improperly repaired. Recommend proper repair by a qualified person.

Wood rot observed at side entry door. Recommend repair by a qualified person.

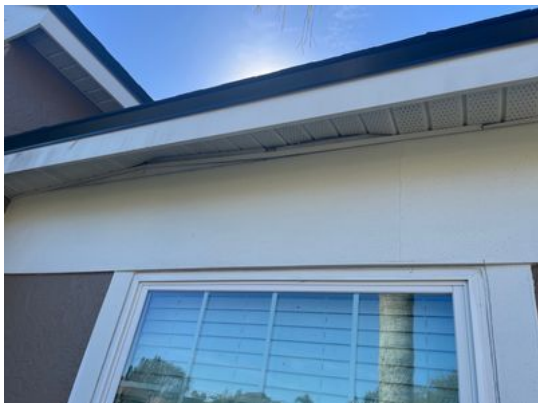
Soffit displaced on north side of home. Recommend adjustment to correct.

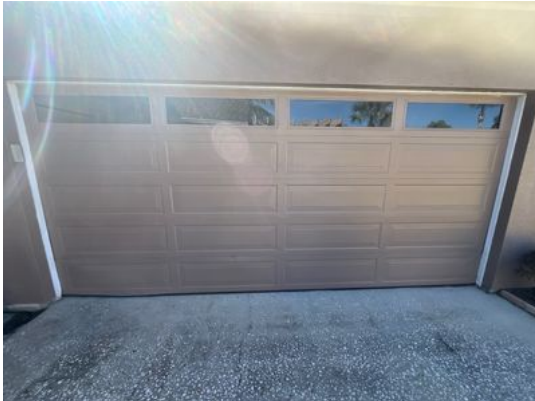
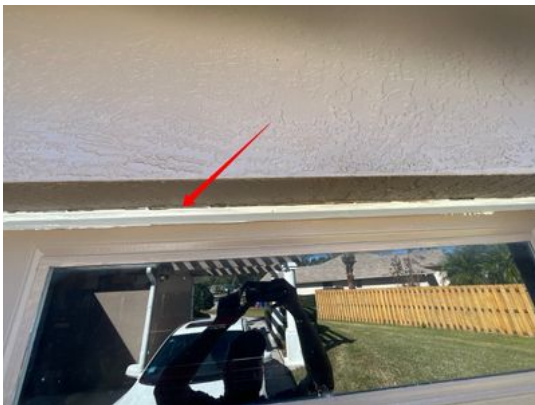
Minor wood rot present at trim surrounding garage door. Recommend repair.

Cosmetic defect noted at lower left side of garage door.

Seals missing along perimeter of garage door. Recommend addition of seals.

Caulking, missing/cracked at top of garage door trim. Recommend resealing

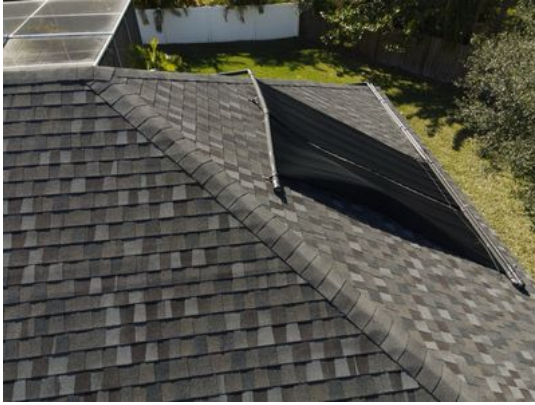
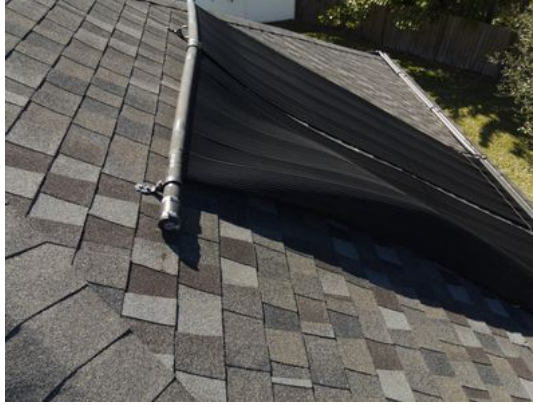
Solar pool heater controls not tested due to damaged panel on roof. Recommend replacement or repair of panel by a qualified professional.

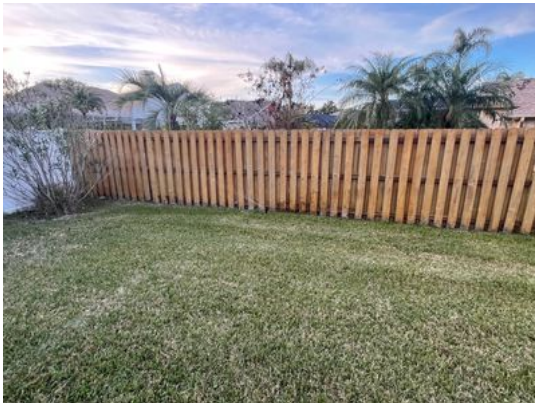
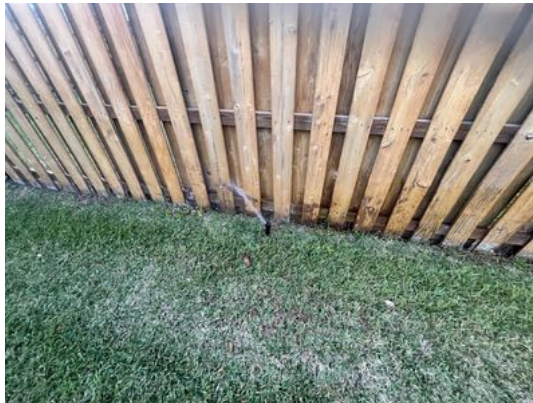
Comment 22

Rotor spraying fence on west side of home. Recommend adjustment.

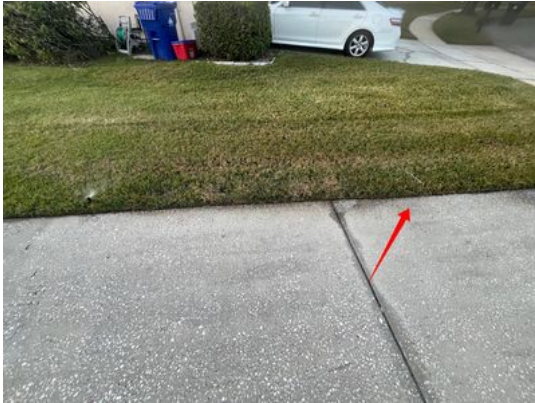
Comment 23

Sprinkler head appears to be clogged; not producing an even spray pattern. Recommend adjustment.

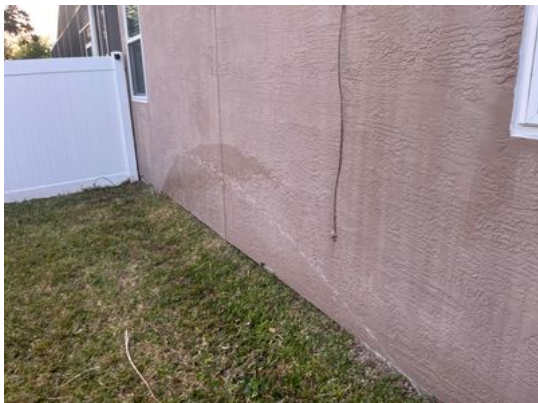
Rotor spraying stucco at east side of home. Recommend adjustment.

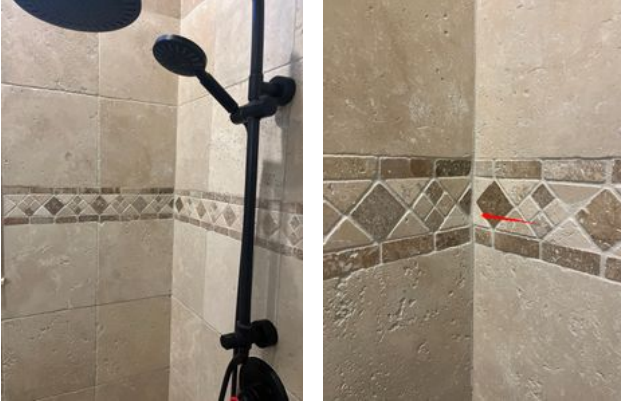
Cracks present in grout in shower enclosure. Recommend repairing grout to prevent moisture intrusion.

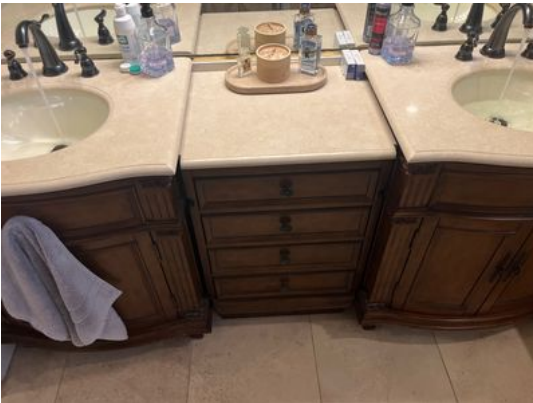
Comment 43

Right sink does not drain properly. Possibly clogged. Recommend maintenance.

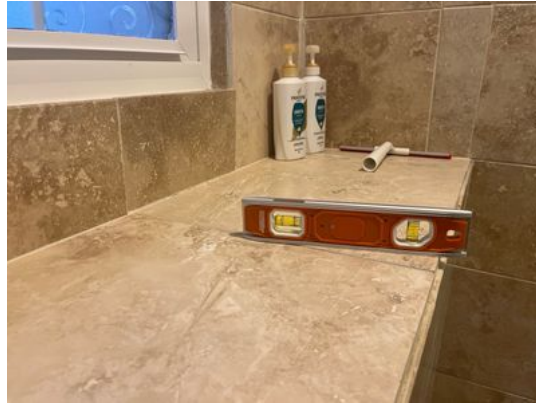
Comment 46

Tile work at shower enclosure slopes towards bay window, preventing proper drainage. Bullnose missing at ledge exposes sharp joint in tile-work.

Tile at window sill creates a pocket that retains water

Recommend consulting with a professional tile installer or general contractor.

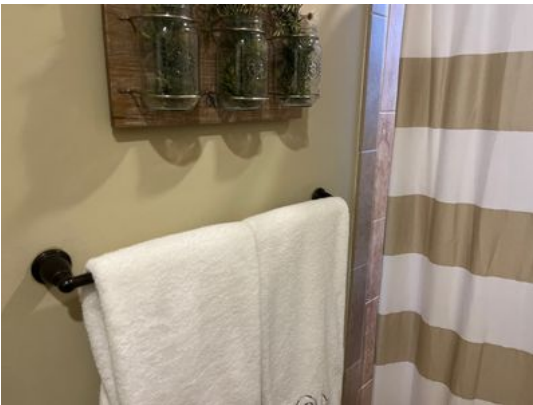
Comment 47

Towel rack loose. Recommend removal and reinstallation to repair.
