High Ground Property Inspections Home Inspection Report

123 Sample Inspection St
Orlando, FL 32812

Inspection Completed On: Sun, Jan 26, 2025 at
9:00 AM

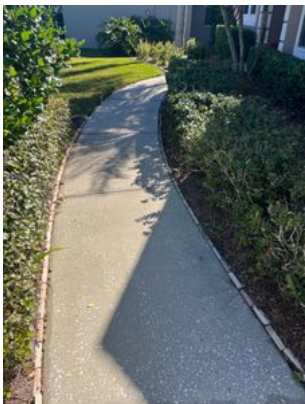
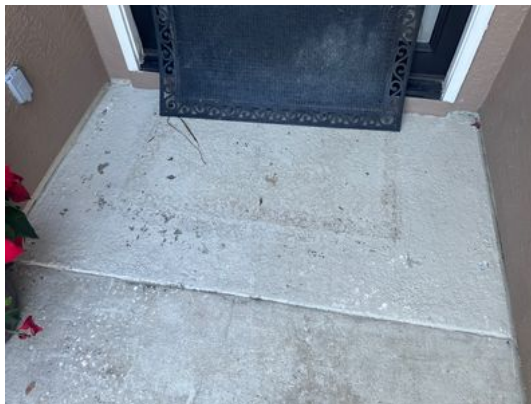
Walkway in good condition. Recommend re-coating paint at entryway surface.

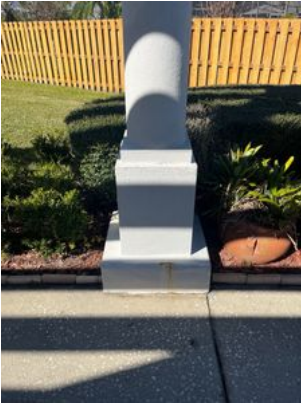
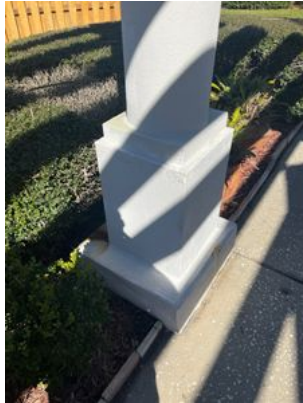
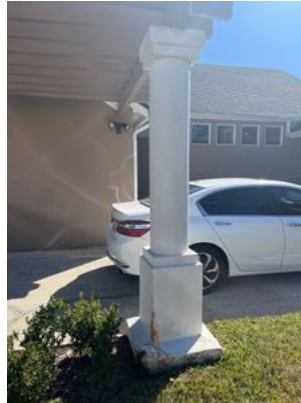
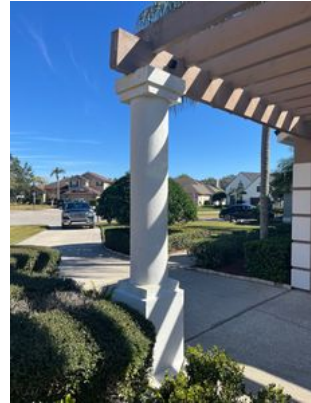
Rust staining present along bases of pergola support columns at west side of home.

Indication of previous repair using caulking in some locations.

Recommend consulting with a repair person to properly seal all surfaces of columns to prevent moisture intrusion.

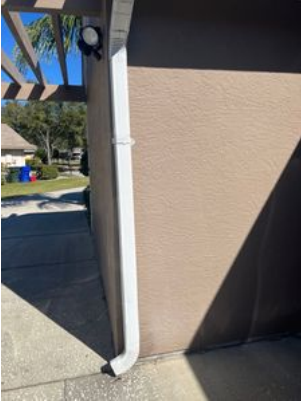
Gutter near garage is loose. Recommend adding additional bracketry to secure.

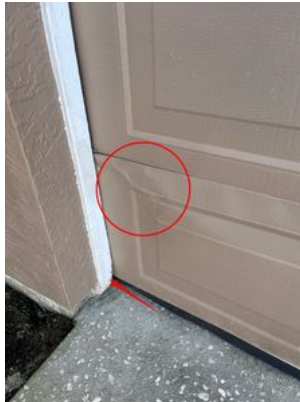
Seals missing along perimeter of garage door. Recommend addition of seals.

Caulking, missing/cracked at top of garage door trim. Recommend resealing

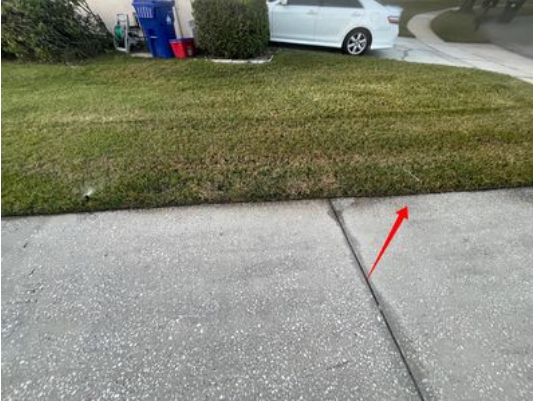
Repair or Replacement Needed

Sprinkler head appears to be clogged; not producing an even spray pattern. Recommend adjustment.

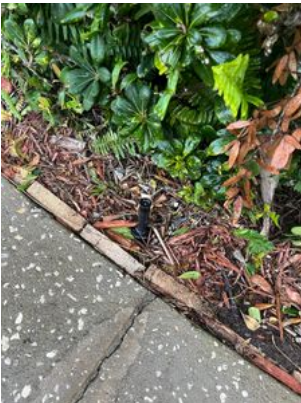
Comment 24

Repair or Replacement Needed

Sprinkler at walkway at front of house not spraying. Recommend adjustment.

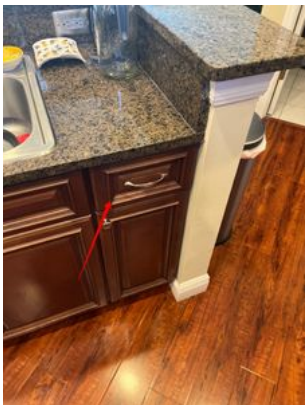
Comment 33

Repair or Replacement Needed

Drawer slide hardware loose on drawer near sink.

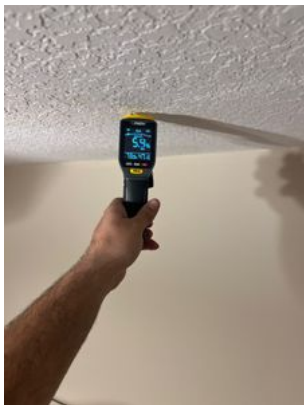
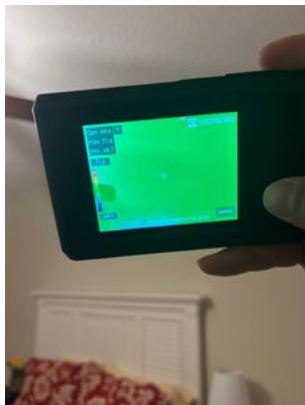
Repair or Replacement Needed

Staining noted on ceiling near exterior entry wall. Surface confirmed as dry using moisture meter and thermal imaging. Recommend repair of affected area by a professional repair person.

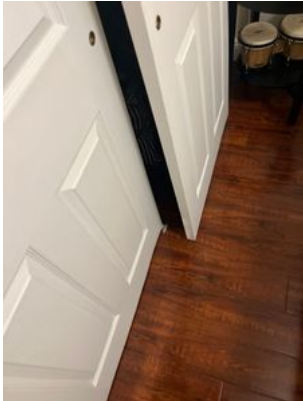
Repair or Replacement Needed

Bottom guide missing at closet sliding door.

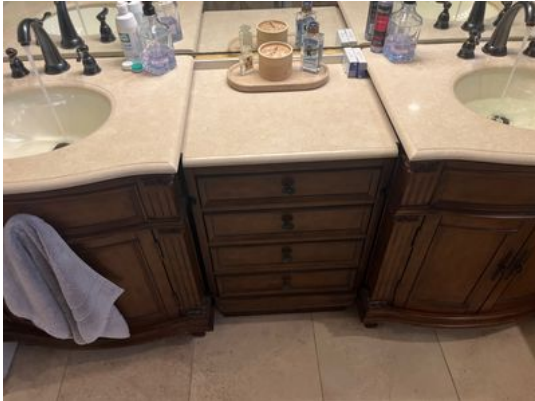
Repair or Replacement Needed

Right sink does not drain properly. Possibly clogged. Recommend maintenance.

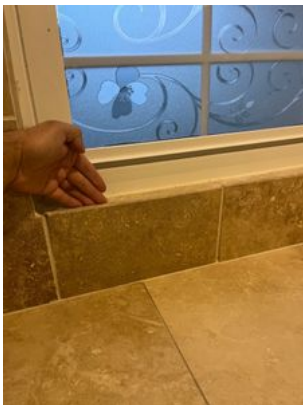
Repair or Replacement Needed

Tile work at shower enclosure slopes towards bay window, preventing proper drainage. Bullnose missing at ledge exposes sharp joint in tile-work.

Tile at window sill creates a pocket that retains water

Recommend consulting with a professional tile installer or general contractor.

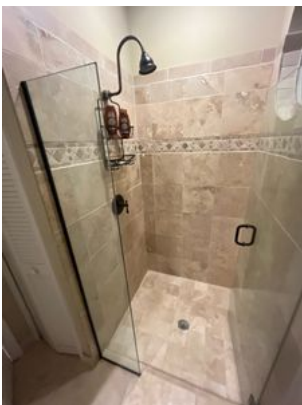
Comment 49 **Information**

Cosmetic defect: Some uneven joints found in tile work.

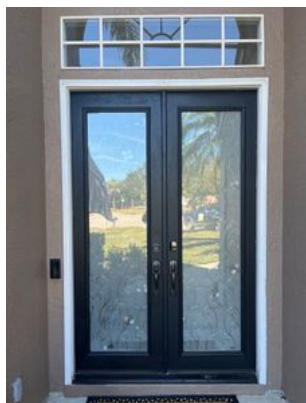
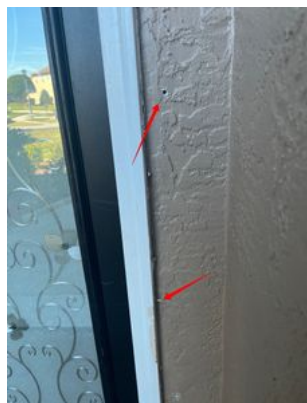
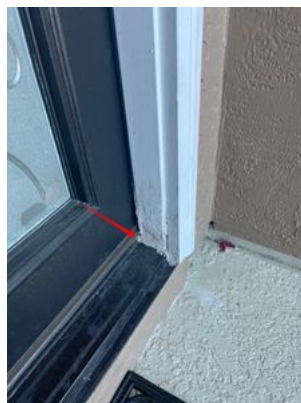
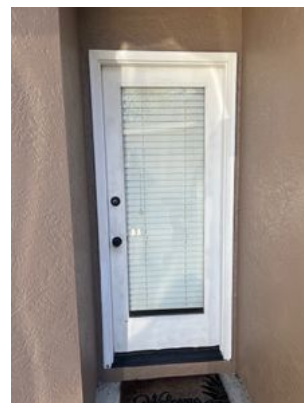
Multiple drilled holes along perimeter of main entry door recommend sealing to prevent intrusion of pests and moisture.

Caulking, along perimeter of main entry door frame has become separated. Recommend resealing.

Wood rot observed at base of main entry door frame, which has been improperly repaired. Recommend proper repair by a qualified person.

Wood rot observed at side entry door. Recommend repair by a qualified person.

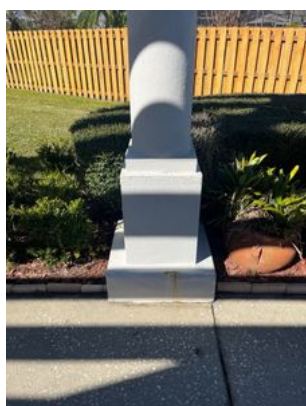
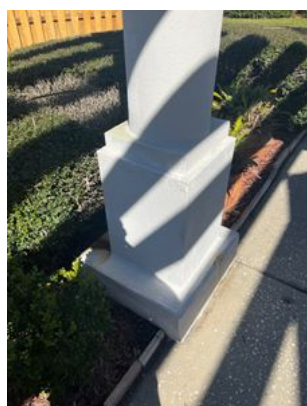
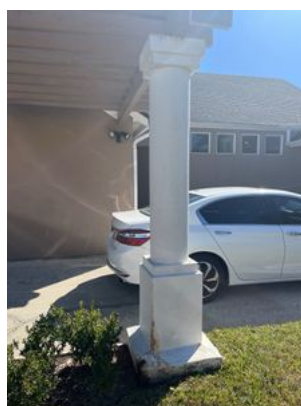
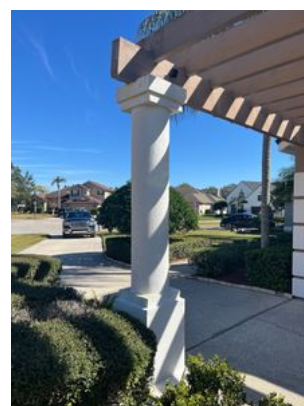
Comment 9

Rust staining present along bases of pergola support columns at west side of home.

Indication of previous repair using caulking in some locations.

Recommend consulting with a repair person to properly seal all surfaces of columns to prevent moisture intrusion.

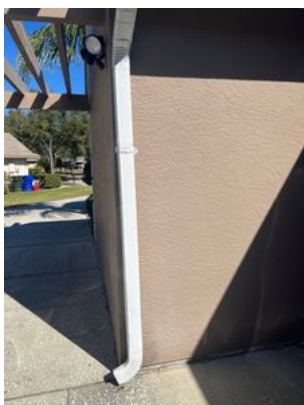
Gutter near garage is loose. Recommend adding additional bracketry to secure.

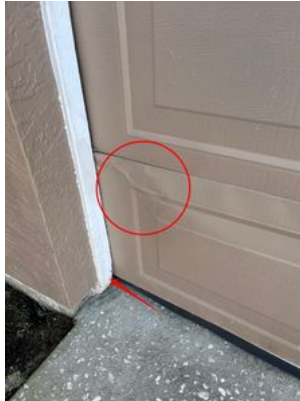
Seals missing along perimeter of garage door. Recommend addition of seals.

Caulking, missing/cracked at top of garage door trim. Recommend resealing

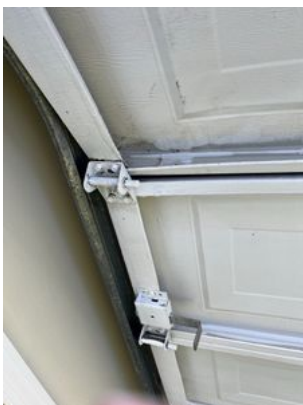
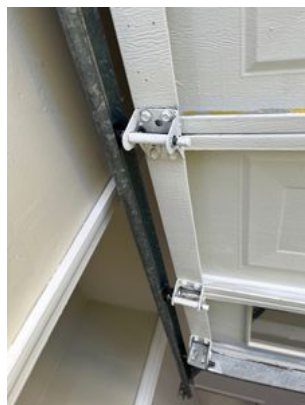
Comment 16

Garage door operates very loudly. Loose hinges identified on left side of door recommend maintenance/repair.

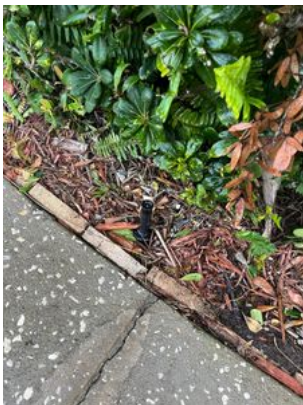
Sprinkler at walkway at front of house not spraying. Recommend adjustment.

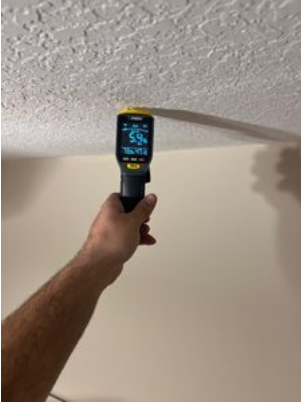
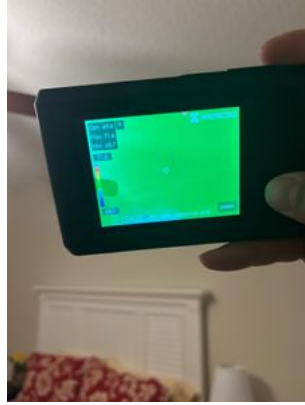
Comment 38

Staining noted on ceiling near exterior entry wall. Surface confirmed as dry using moisture meter and thermal imaging. Recommend repair of affected area by a professional repair person.

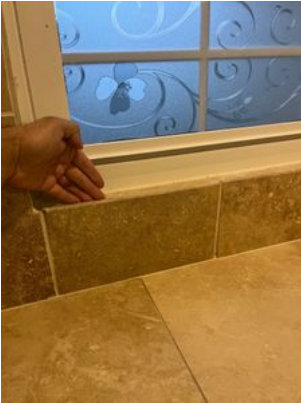
Tile work at shower enclosure slopes towards bay window, preventing proper drainage. Bullnose missing at ledge exposes sharp joint in tile-work.

Tile at window sill creates a pocket that retains water

Recommend consulting with a professional tile installer or general contractor.
